Inspection Report

54321 Manor PI NW
Stanwood, WA 98292

ABODE Inspection Services LLC

2/4/2014

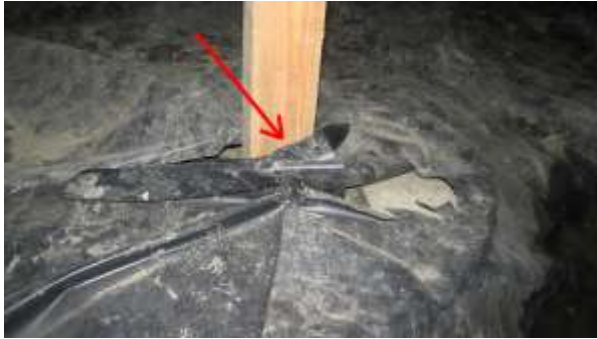
2. Repair, WDO :-> The plastic vapor barrier has been run up onto the wood framing (support posts) and should be removed to prevent water being delivered to the wood framing of the home.

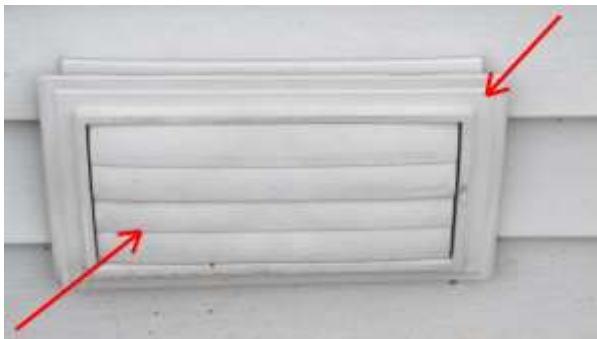
3. Repair, WDO :-> Crawl space air vents have been obstructed. This is non-standard and reduces dry potential in this space and could lead to moisture problems. Have a qualified contractor remove the plastic covers and install 1/4 inch mesh screens.

Remove.

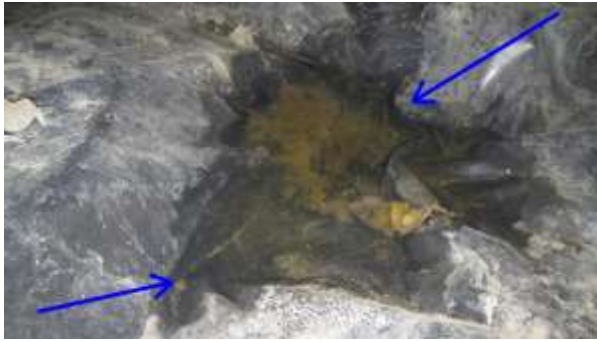
4. Major Concern, WDO :-> Moderate water was noted in the crawl space. This condition may change seasonally, or with rain intensity. Moisture is bad for crawl spaces and can lead to interior molds, structural settlement and wood destroying organisms. Hire a drainage specialist to further evaluate and correct this condition. Also see the Drainage section of this report for observations regarding any exterior drainage repairs that are needed.

Crawlspace has standing water in several areas.

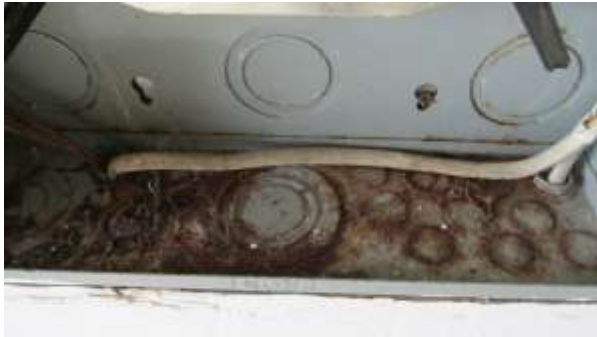
6. Repair :-> The electric panel in the home is corroded and requires further evaluation from a licensed electrician to insure safe and reliable performance. Corrosion inside the panel is a red flag that the panel is having moisture problems and this could result in poor and unsafe wiring connections. Repair or replace as recommended by a licensed electrician.

Corrosion in Main Electrical Service Panel

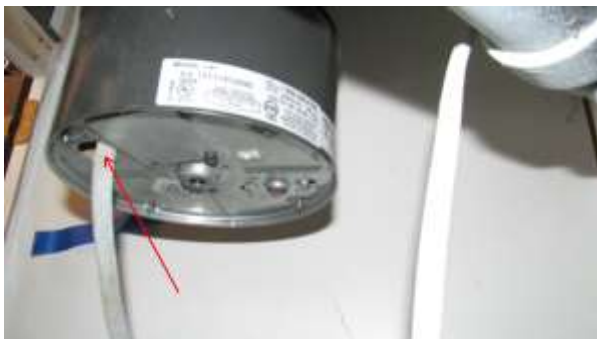
7. Repair :-> Bushing/grommet needed where electrical wire enters garbage disposal to protect wire from physical damage.

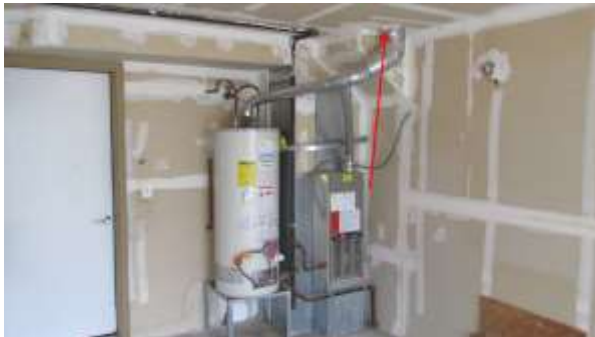
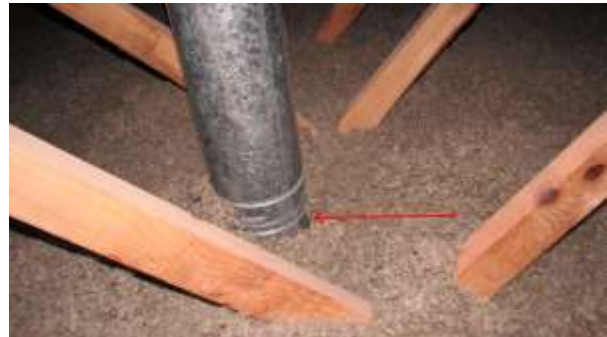
12. Repair :-> The B-vent for the furnace flue has inadequate clearance from combustible materials and insulation. A one inch clearance is recommended for these pipes. Move/Cut combustible materials back and use metal flanges to seal openings in finishes. Noted where B=vent enters the sheetrock in the garage ceiling and in the attic where it is surrounded by insulation. Hire qualified contractor to repair as needed.

B-Vent is without the 1 inch recommended clearance to combustibles

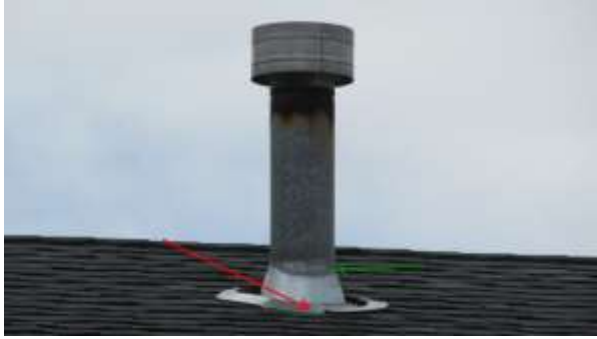
13. Repair -> Metal Collar tie that is designed to help keep water out of the roof flashing for the furnace vent pipe has become unfastened and is lying down on the roof. Have contractor repair as needed.

Red arrow points to collar that should be tightly wrapped around the pipe where the green arrow is pointing, and then caulked to prevent water entering the attic.

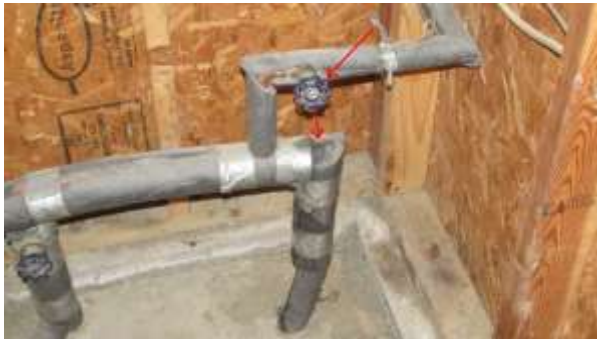
14. Repair -> Minor leak by shut-off valve for front exterior faucet, this is located in SE garage corner. Have this repaired by a licensed plumber.

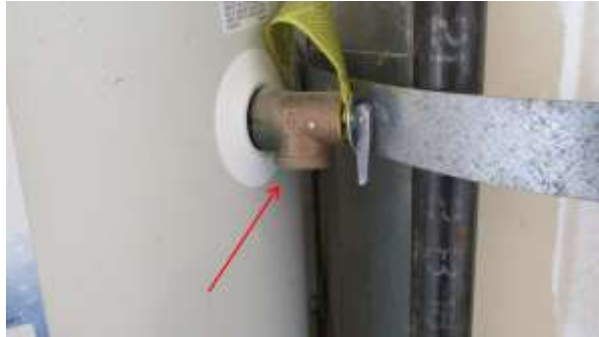
16. Repair :-> The discharge tube for the water heater relief valve is inadequate. Discharge tubes should always terminate by pointing toward the ground to eliminate a scald hazard and should be between 6" and 18" off the ground. Ideally, the discharge tube terminates to an exterior or unfinished location or above a drain, though this is not always possible. The drain should also slope to drain to prevent water pooling inside the discharge tube. Have a licensed plumber install a TPRV discharge pipe.

TPRV is missing discharge pipe.

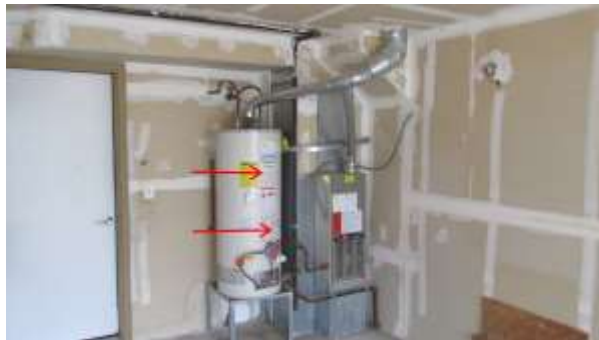
17. Repair :-> Install listed seismic straps to support the water heater in the event of an earthquake; none were noted during inspection. Two straps should be installed. One old strap is present but not installed.

No earthquake straps around the water heater.

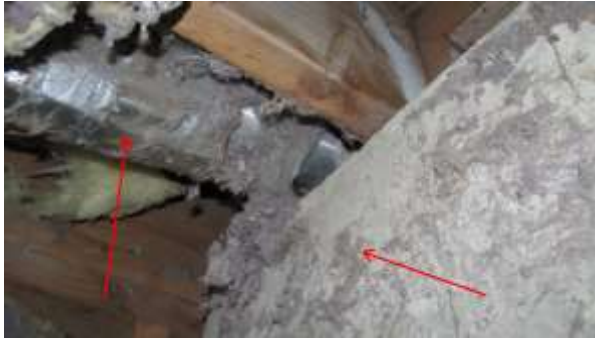
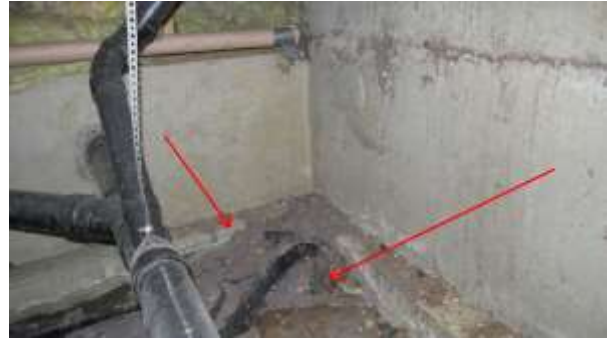
19. Repair -> Repair or replace the disconnected dryer vent. The excessive moisture this contributes is a conducive condition for wood destroying organisms. Be sure the dryer is vented to the exterior. Use rigid metal pipe only in concealed spaces such as the crawl space. This vent has deposited substantial amount of dryer lint into the SW area of crawlspace.

Dyer lint is piling up in many places around this area.

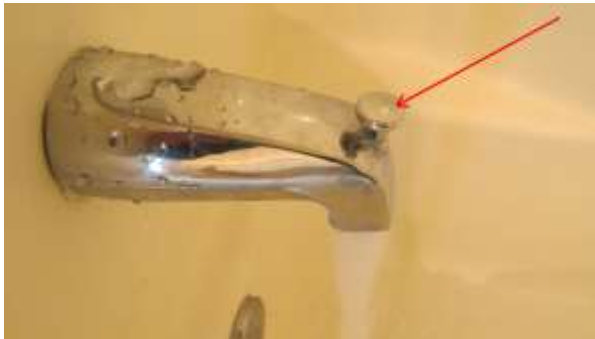
21. Repair :-> The bath tub faucet shower diverter was not operational, could not switch water up to shower head. Have plumber repair.

The diverter handle would not lift up to divert water to the shower head.

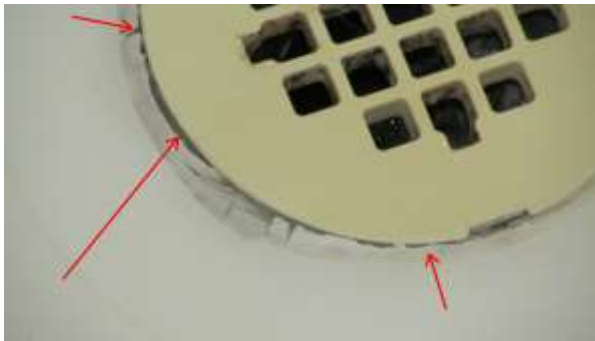
24. Repair :-> Shower Drain seal appears to have a gap in its seal and could potentially leak, have plumber further evaluate and repair as needed.

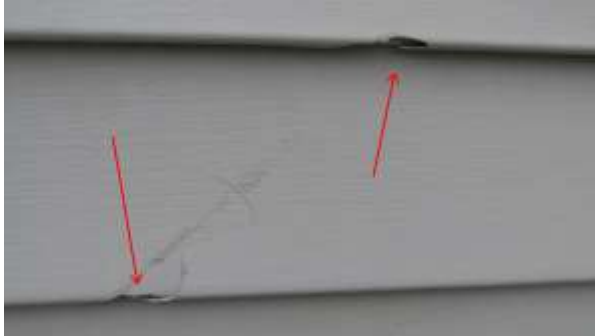
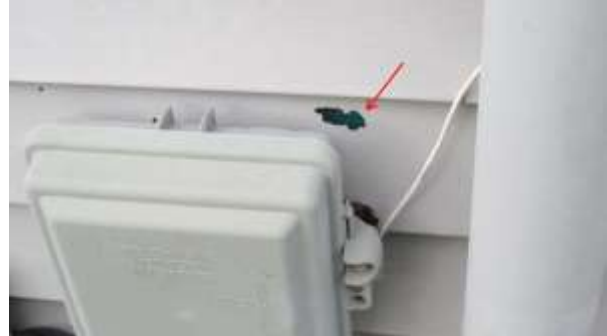
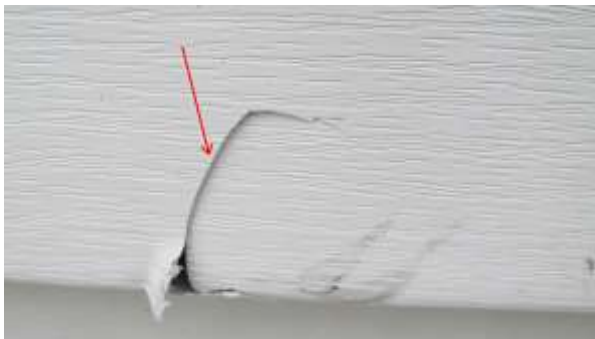
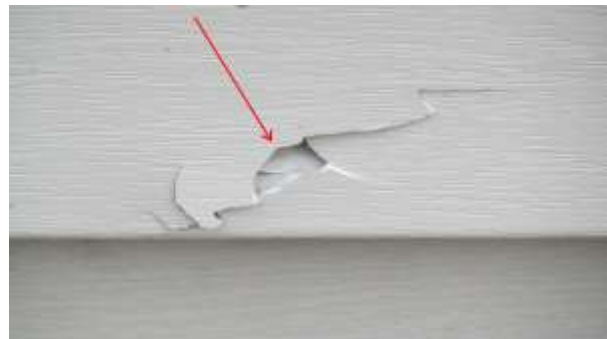
28. Repair :-> Localized vinyl siding repairs are needed to the exterior vinyl siding. See photos attached for specific details. Please note that vinyl siding is impossible to see behind and it is impossible to tell if these defects have allowed water to enter the siding envelope or not. Hire a vinyl siding specialist to further evaluate and repair.

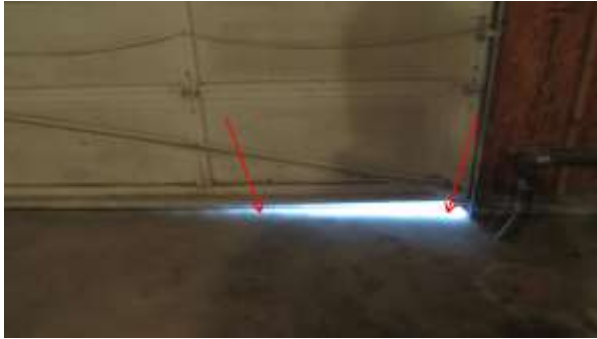
30. Repair :-> Repair the damaged or inadequate weather stripping on the bottom of the garage door at the south side. This is important to prevent water and rodent entry.

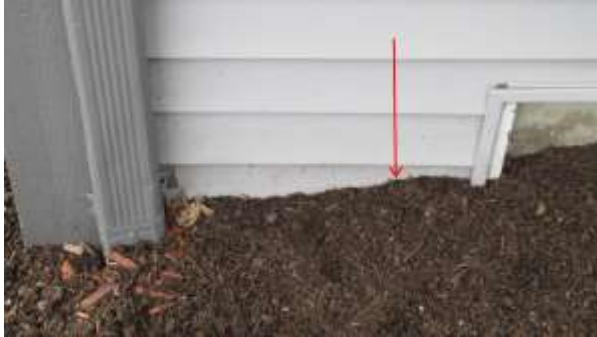
32. Repair -> Eliminate siding /soil contact to reduce the chances for rot and pest damage and repair any hidden rot as needed. Generally, a 6 inch clearance between soils and wood is recommended. This is often not realistic on older homes, but repairs should be made to get as much clearance as is possible and all contact must be eliminated.

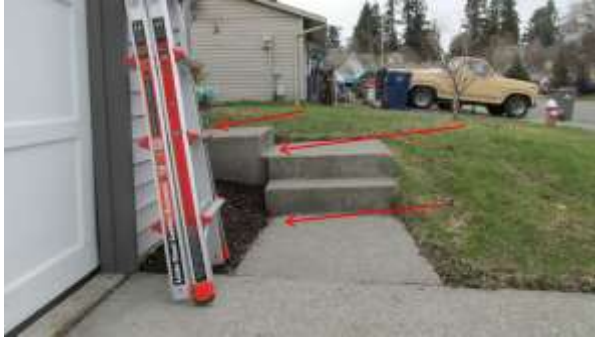
34. Repair :-> The exterior concrete stairway leading to the main entry is sloping towards the house. It should slope away from house. This condition could contribute to foundation settling or excessive moisture in crawlspace. The concrete flatwork appears to have settled significantly. This can be difficult to correct as it may necessitate rebuilding the stairs. Hire a qualified contractor to further evaluate and repair.
