Inspection Report

54321 Manor PI NW
Stanwood, WA 98292

140204A

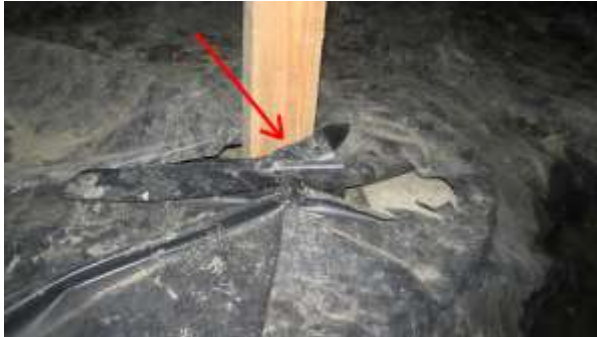
2. Repair, WDO :-> The plastic vapor barrier has been run up onto the wood framing (support posts) and should be removed to prevent water being delivered to the wood framing of the home.

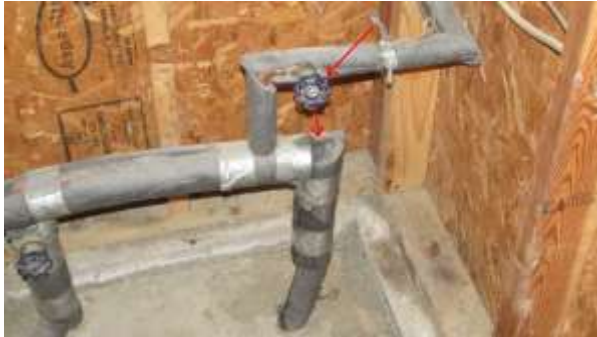
14. Repair -> Minor leak by shut-off valve for front exterior faucet, this is located in SE garage corner. Have this repaired by a licensed plumber.

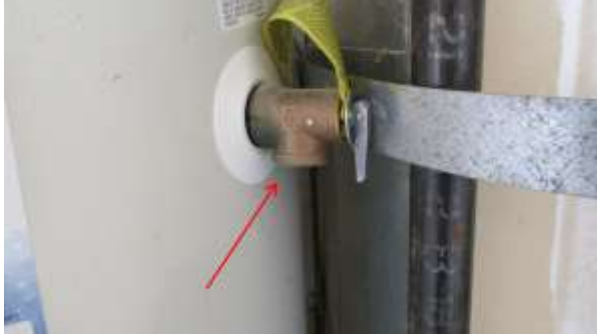
16. Repair :-> The discharge tube for the water heater relief valve is inadequate. Discharge tubes should always terminate by pointing toward the ground to eliminate a scald hazard and should be between 6" and 18" off the ground. Ideally, the discharge tube terminates to an exterior or unfinished location or above a drain, though this is not always possible. The drain should also slope to drain to prevent water pooling inside the discharge tube. Have a licensed plumber install a TPRV discharge pipe.

TPRV is missing discharge pipe.

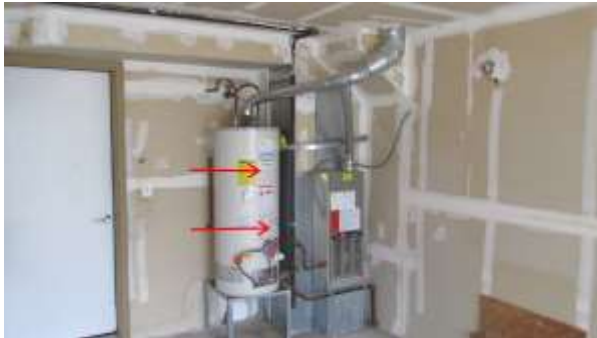
17. Repair :-> Install listed seismic straps to support the water heater in the event of an earthquake; none were noted during inspection. Two straps should be installed. One old strap is present but not installed.

No earthquake straps around the water heater.

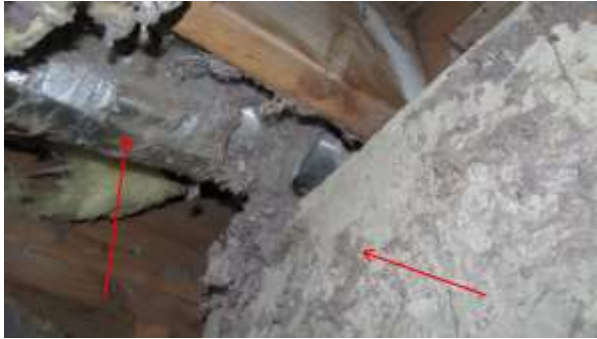
19. Repair -> Repair or replace the disconnected dryer vent. The excessive moisture this contributes is a conducive condition for wood destroying organisms. Be sure the dryer is vented to the exterior. Use rigid metal pipe only in concealed spaces such as the crawl space. This vent has deposited substantial amount of dryer lint into the SW area of crawlspace.

Dyer lint is piling up in many places around this area.

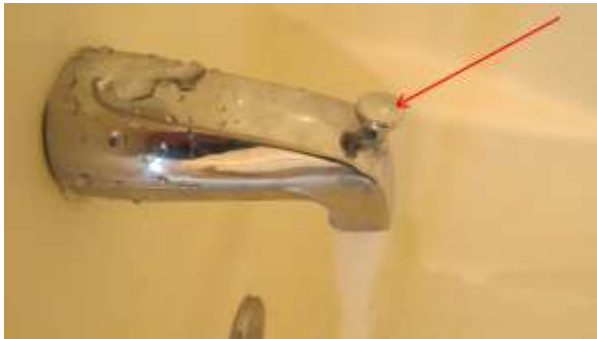
21. Repair :-> The bath tub faucet shower diverter was not operational, could not switch water up to shower head. Have plumber repair.

The diverter handle would not lift up to divert water to the shower head.

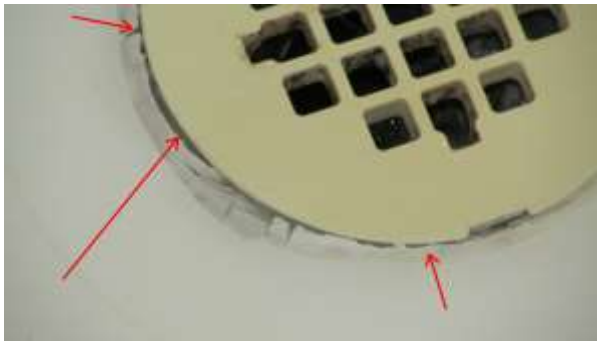
24. Repair :-> Shower Drain seal appears to have a gap in its seal and could potentially leak, have plumber further evaluate and repair as needed.

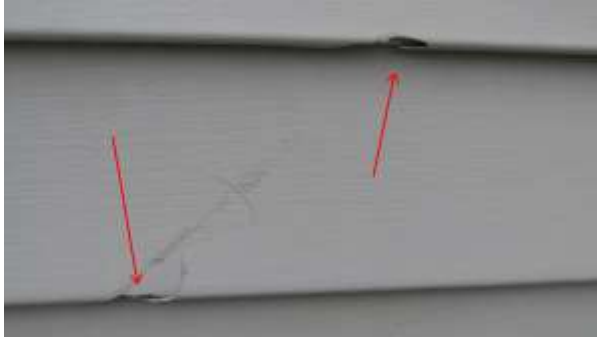
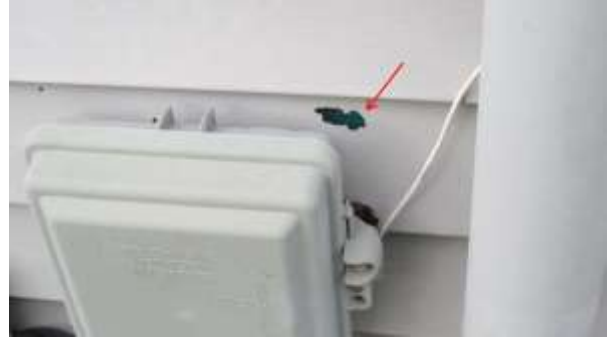
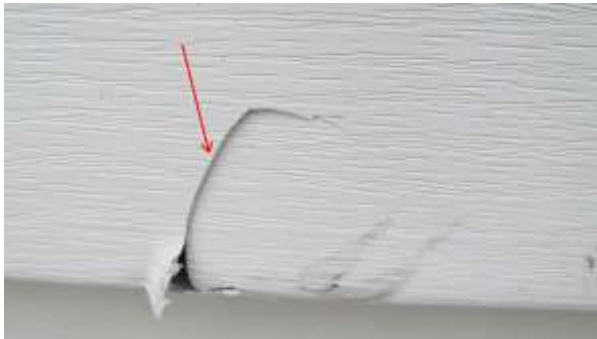
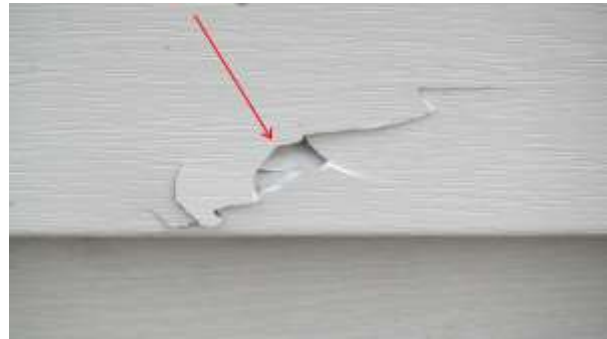
28. Repair :-> Localized vinyl siding repairs are needed to the exterior vinyl siding. See photos attached for specific details. Please note that vinyl siding is impossible to see behind and it is impossible to tell if these defects have allowed water to enter the siding envelope or not. Hire a vinyl siding specialist to further evaluate and repair.

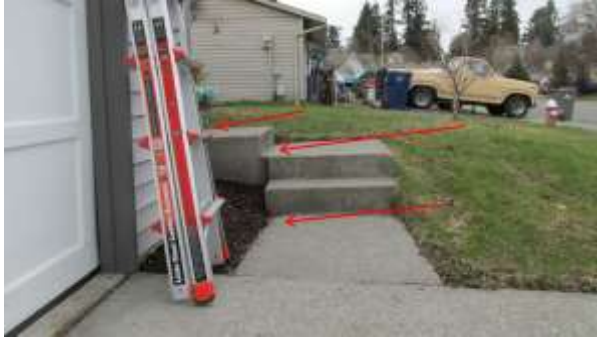
34. Repair :-> The exterior concrete stairway leading to the main entry is sloping towards the house. It should slope away from house. This condition could contribute to foundation settling or excessive moisture in crawlspace. The concrete flatwork appears to have settled significantly. This can be difficult to correct as it may necessitate rebuilding the stairs. Hire a qualified contractor to further evaluate and repair.
